THE HERITAGE SPECTATOR

总第21期 No. 21

2025.05 (内刊)

历史建筑及遗址的重建：保护原则与文化背景

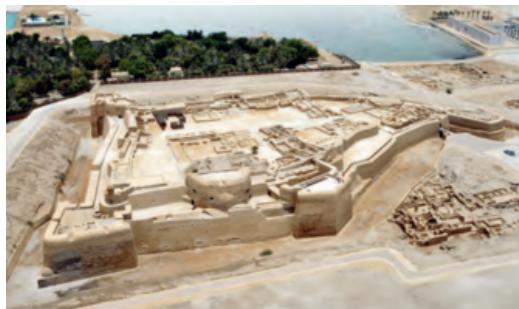
图1：巴林堡，巴林。该堡垒被重建为巴林人民的民族象征。
Figure 1. Qal'at Al-Bahrain, Bahrain. The fort was reconstructed as a national symbol to the Bahraini people.

Needless to mention, the reconstruction of historic buildings and sites is still appealing to both the public and custodians of heritage properties. It has often been justified on the basis of values that are beyond aesthetic, historic or age values. These have included national symbolic or identity values such as the reconstruction of a place with exceptional symbolic value to society. For example, Qal'at Al-Bahrain fort was reconstructed as a national symbol to the Bahraini people (Figure 1). Also under this category, reconstruction is often a response to destruction and is an expression to restore the identity of people's values that are sometimes under threat (Figure 2). For example, at Al-Shandagha historic district in Dubai rebuilding of the area and houses was as a response to destruction in 1990s and is an expression to restore the people's identity where the Ruling family and merchants used to live.

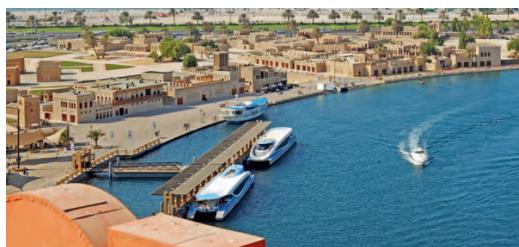
图2：辛达加历史街区，迪拜，为应对1990年代的破坏而重建，旨在恢复包括统治家族及商人在内的人们的身份认同。
Figure 2. Al-Shandagha historic district, Dubai, rebuilt as a response to destruction in 1990s and is an expression to restore the identity of people's values including the Ruling family and merchants.

回应，是恢复那些有时受到威胁的价值认同的一种表达（图2）。例如，重建迪拜的辛达加历史街区是对1990年代破坏的一种回应，也是恢复人们身份认同的一种表达，这里曾是统治家族及商贾阶层的聚居地。

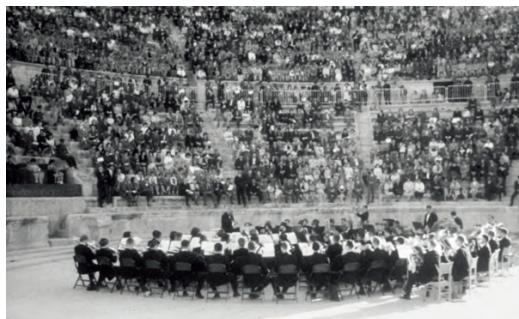
图3: 约旦安曼的罗马剧场进行部分重建，延续先前的庆典功能。
Figure 3. The Roman Theatre in Amman, Jordan partially reconstructed to continue to serve its previous function for festivities.

重建的正当性还体现在“使用价值”。重建可以继续发挥建筑之前的功能，或提供新的功能，例如将剧场遗址用于庆典活动。位于约旦安曼的罗马剧场和戏院就被重建以继续服务于其先前的庆典功能（图3）。此外，重建被用于游客的教育手段的“教育及信息价值”往往由“经济与旅游价值”所驱动。

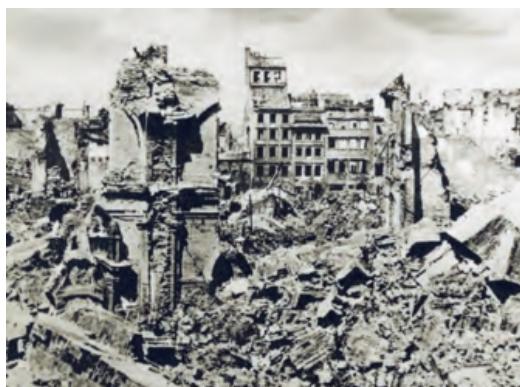
图 1: 1945 年的华沙老城废墟
Figure 1. The ruins of Warsaw Old Town in 1945

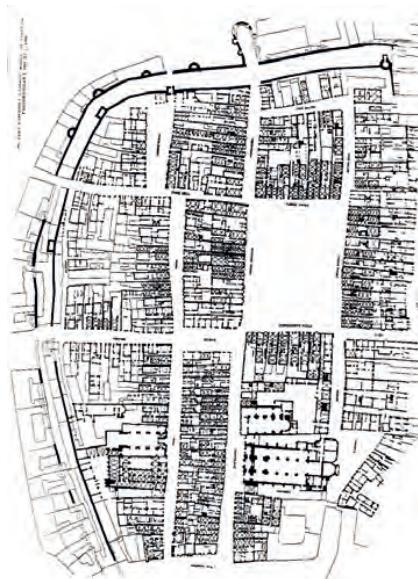
图2：华沙老城 - 房屋及城市防线中的哥特元素清查，1932-1939（波兰建设部档案）。

Figure 2. Warsaw Old Town - Inventory of Gothic elements in houses and the lines of the city defence, 1932-1939 (The archive of Polish Architecture Department - ZAP).

及波兰的其他历史城镇、建筑群和古迹，在二战前都以平面图和剖面图等形式记录了建筑和城市的测绘数据。这一文献记录工作由华沙理工学院的学生完成，旨在进行专业的建筑实践练习。二战后，这些文献构成了华沙重建的基础，不仅包括中世纪的老城和新城，也包括了自皇家城堡沿克拉科夫郊区街至诺维思维亚特的皇家路线，沿途分布着许多十七世纪的贵族宫殿以及十九世纪的纪念性公共建筑和广场。这些文献的价值不仅体现在历史建筑的重建上，它还揭示了考古研究和发掘中发现的中世纪城市布局。

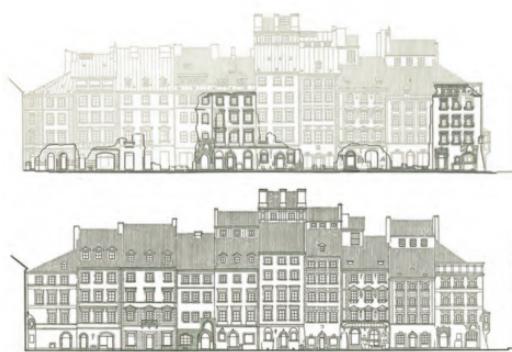
图 3：插图展示了市场广场的立面形态。在上图中，深色表示清除瓦砾后核定的建筑遗迹，背景的浅灰色为战前的测绘图。下图是重建项目的设计图。（波兰建设部档案）

Figure 3. Illustrations show the Market Square frontages. In the top elevation, the dark colour indicates remains of houses assessed after the removal of rubble, against the background of the pre-war survey, which is in light grey. The bottom elevation is a drawing for the reconstruction project design. (The archive of Polish Architecture Department - ZAP)

1939 年的建筑清查展示了老城在被毁前的发展状况，例如市民住宅的地下室和一层平面等。这些图纸是重建项目的基础。每栋房子都有一段立面，它们共同构成了市场广场的整个立面形态。

It is not difficult to notice how closely the reconstruction project design (the dark colour) and the pre-war survey (in light grey) correspond to each other. It is clearly visible how much of the original structures was preserved. Where the existing structures demonstrated suitable technical conditions for reconstruction they were integrated into the rebuilt buildings and façades. Since the original foundations were reused, most of the cellars remained authentic, as did many walls and details at ground-floor level as well as on the upper floors. This also applies to some of the stone window casements and some original portals, either in part or in whole; elements that are Gothic, Renaissance or Baroque, corresponding to the style of the original pre-war buildings.

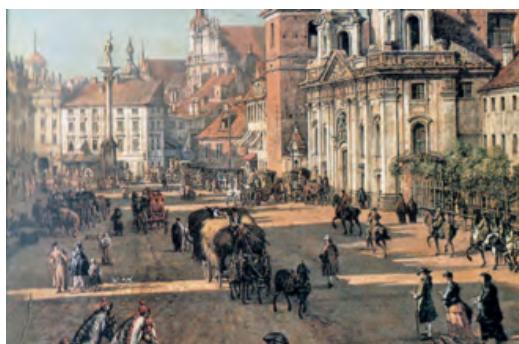
图 4：贝纳多·贝洛托，从克拉科夫郊区街看华沙老城的景色，1767。

Figure 4. Bernardo Bellotto, view to the Warsaw Old Town from Krakowskie Przedmieście, 1767.

除历史照片和图纸外，重建所参考的特定资料还包括贝纳多·贝洛托（又名卡纳列托）绘制的十八世纪城镇风光。这对于重建从维斯瓦河看到的老城全景尤其有效。贝洛托使用暗箱来绘制他的风景画，使得画作几乎与照片一样精确。他热衷于将街道和宫殿描绘到画布上。他所绘制的华沙宫殿在重建所谓皇家路线沿途的建筑和古迹的工作中发挥了巨大作用，这条路线从克拉科夫郊区街的皇家城堡一直延伸到维拉努夫的巴洛克风格皇家乡村住宅，这所住宅采用了类似凡尔赛宫的设计风格。老城的重建工作始于 1949 年，历时不到四年。然而，对于波兰的知识分子来说，在象征意义上，它并没有完工。直到 1983 年，重建的皇家城堡重新开放，它才是波兰民族的真正象征，这座城堡是 1918 年波兰独立后第一届政府所在地。

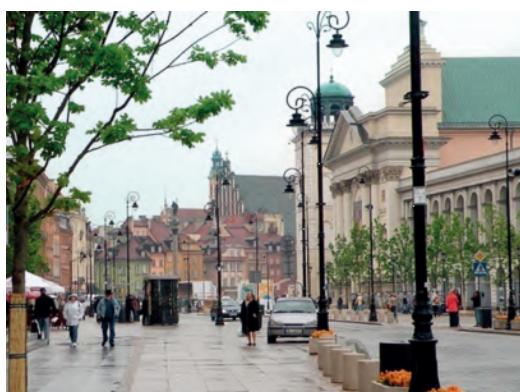
图5. 华沙老城。从城堡广场到大教堂和耶稣会教堂塔楼的景色，2008年（摄影：克洛谢克·科兹洛夫斯卡）
Figure 5. Warsaw, the Old Town. View from Zamkowy Square to Cathedral and the tower of the Jesuit Church, 2008. (Photo: D. Klosek-Kozlowska)

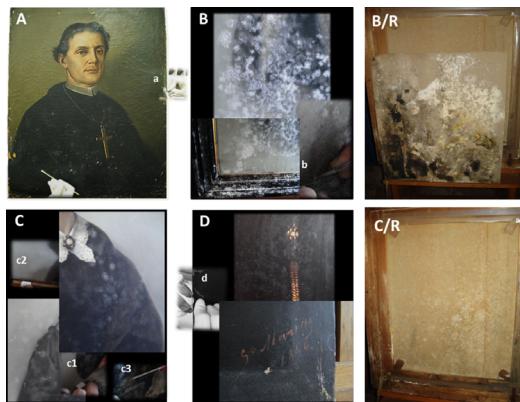
图 1：乔治·马里尼肖像画，标记采样区域：A. 《弗雷·曼努埃尔·多·塞纳库洛》，1887 年 (ME1281)，埃武拉博物馆；B. 留胡子的男士肖像，1897 年；C. 女士肖像，1897 年，私人收藏 (葡萄牙埃武拉)；D. 女士肖像，1886 年，私人收藏 (葡萄牙埃武拉)。B/R 表示 B 画作背面，由纸板覆盖，C/R 表示 C 画作背面。小写字母 (a, b, c1, c2, c3 和 d) 表示为材料表征收集的微片。Figure 1. Portraits by Giorgio Marini with evidenced sampling areas: A portrait of Frei Manuel do Cenáculo, 1887 (ME1281), Museum of Évora; B portrait of a bearded gentleman and C portrait of a lady, 1897, private collection (Évora, Portugal); D portrait of a lady, 1886, private collection (Évora, Portugal). B/R Reverse side of the painting B covered by a cardboard and C/R reverse side of the painting C. Small letters (a, b, c1, c2, c3 and d) indicate the micro-fragments collected for materials characterization.

采样过程遵循保护原则，在靠近缺失部分、边缘或裂缝处采集了测试所需的最小计量，从而避免对艺术品造成结构和美学损伤。研究采用非侵入和微侵入方法，在无菌条件下收集了多份画作样本。最终，通过无菌棉签收集生物膜样本共 28 份，用于可培养的真菌群落表征，其中画作正面 18 份（图 1A-D），背面 10 份（图 1B/R、C/R）。

The sampling process was made according to the conservation ethics, collecting the minimum amount required for testing, near lacunae, edges or fissures, avoiding thus structural and aesthetic damage to the artwork. Several samples of the artworks were collected using non-invasive and microinvasive methods, in sterile conditions. A total of 28 biofilm samples using sterile cotton swabs were collected, 18 from the obverse side of the paintings (Figure 1A-D) and 10 from the reverse side (Figure 1B/R, C/R) for characterization of the cultivable fungal communities.

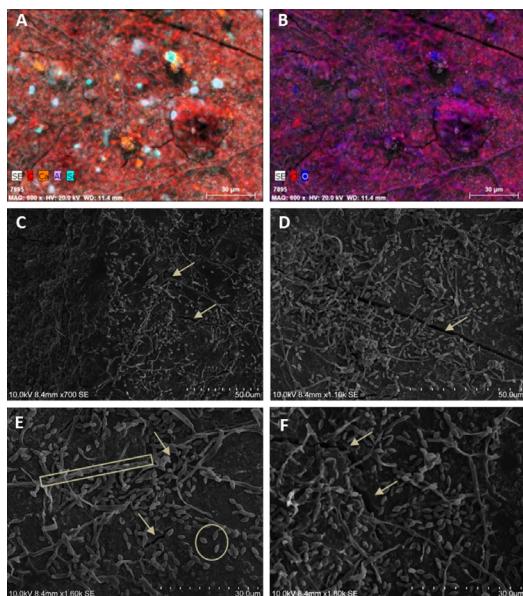
图 2：通过二维映射进行的化学分析 (A, B) 和从可见受影响区域采集的油画微片的扫描电子显微镜图像 (C-F)。箭头指示了丝状真菌大量增殖和菌丝深入内部的位置，这些位置的画作表面均出现了裂缝，E 图的方框和圆形分别显示了一根菌丝和真菌孢子。

Figure 2. Chemical analyses by 2D mapping (A, B) and SEM micrograph of easel paintings micro-fragments collected from visible affected zones (C-F). The arrows indicate the appearance of cracks in the surface of paintings with the presence of high proliferation of filamentous fungi and the penetration of the hyphae in depth and the box and circle E evidence one hypha and fungal spores, respectively.

SEM 观察结果证实，丝状真菌的存在以及菌丝在与颜料层材料的密切接触中大量增殖，并进一步在样本深层扩散，这或许可以解释画作中一些裂缝的产生。结果表明，真菌增殖似乎是这些油画美学和结构退化的主要因素。

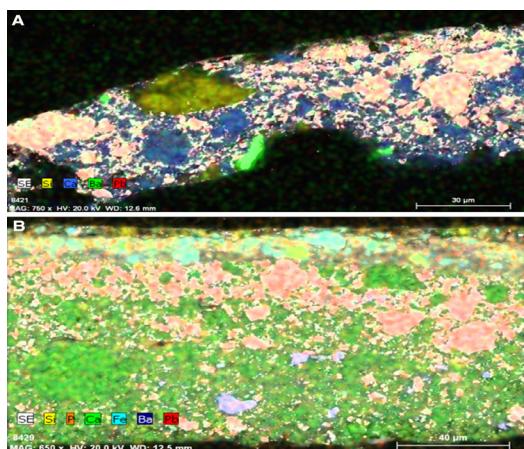
图 4: 女性肖像 (A) 样本横截面的显微照片，显示了不同层中铅、钡、钙和硅的元素分布；男性肖像 (B) 的样本横截面，显示了不同层中铅、钡、铁、钙、磷和硅的元素分布。

Figure 4. Micrograph of the cross section of a sample from the portrait of a lady (A) showing the elemental distributions of the different layers with lead, barium, calcium and silicon; and the portrait of a man (B) showing the elemental distributions of the different layers with lead, barium, iron, calcium, phosphorus and silicon

研究结果显示, 涂在支撑架上的第一层材料由铁、铝硅酸盐和铅白的混合物组成, 而上一层白色则由铅白和少量碳酸钙 (也用作颜料中的填充剂或增稠剂) 组成。这些结果与十九世纪画作的预期一致。能量色散光谱还在两幅肖像的第一层底料中发现了钡 (图 4A)。钡是硫酸钡 (即钡白) 存在的指标, 这种物质在 1820 年后主要用作铅白的填充剂。由于钡白仅出现在图 4A 的第一层底料, 而未出现在上层中, 这表明它并非艺术家所用铅白的商业配方之一。鉴于当时的普遍做法, 这可能是因为艺术家购买的画布已经预先涂有工业底料。
